PRECIOSO CLINICAL DATA SUMMARIES

Pre launch report on clinical evaluations

The Precioso Alternating Pressure Mattress Replacement and Mattress Overlay Systems

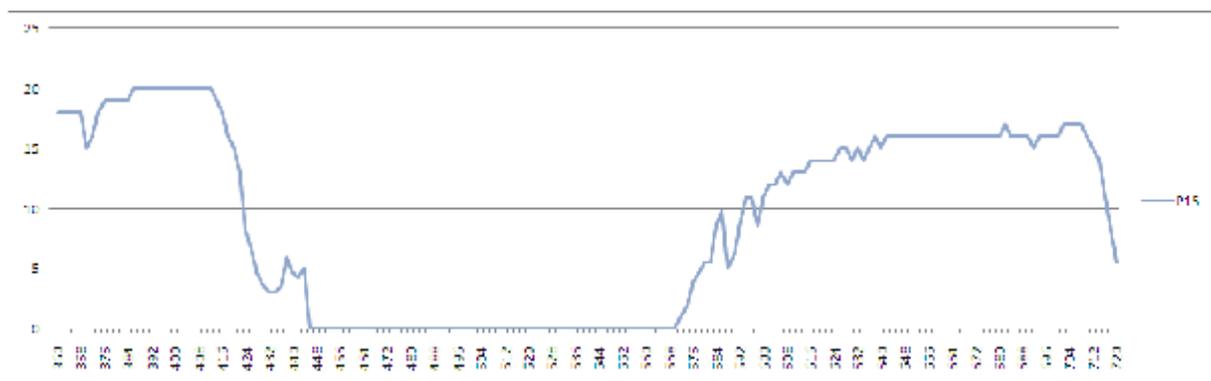
Example 1: A 53Kg female (illustrated above) pressure range on the sacrum 0 – 20mmHg with a mean of 9.5mmHg

The focus of the evaluation was to observe the low pressures achieved at the highest pressure area (Sacrum). The scans were analysed by focussing on the identified sacral area of high pressure and observing the cycle through from inflated to deflated and return. The pressures being noted down at the various stages of the cycle, with the lowest values being reported on.

Initial findings show that the Precioso MR provides excellent pressure reducing properties

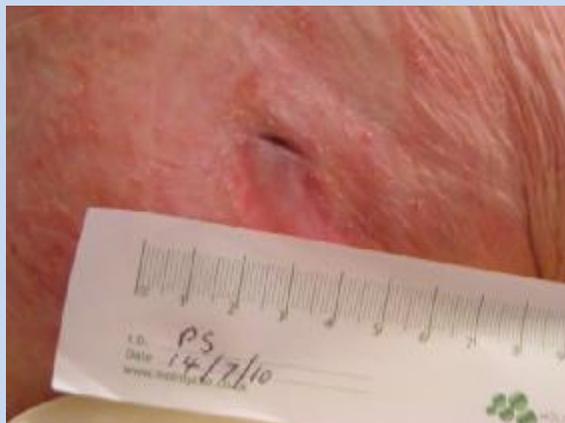
Week 16 - Ulcer 0.5cm x 0.2cm and 100% granulation.

Ulcer site at end of evaluation period

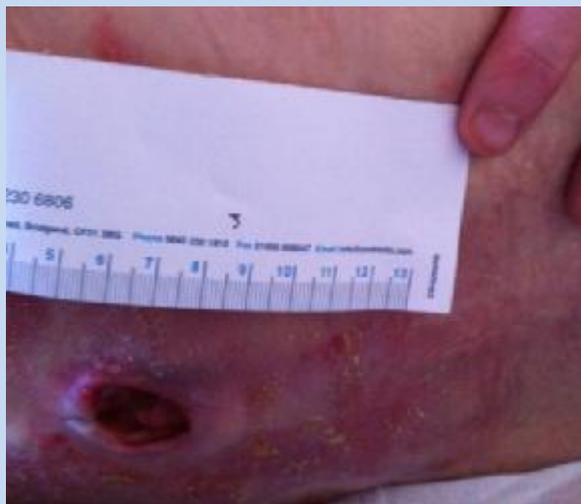
The Sacral pressure ulcer was assessed as;
Grade 3 measuring 2.5cm x 2.4cm occluded by 25% slough, 25% Escar with the remaining 50% of the wound dull granulation tissue.

Sacral Pressure Ulcer at 12 weeks into evaluation.
